# SURFACE REMAINS OF THE NEW VENTURE LEAD MINE BRADWELL MOOR, DERBYSHIRE. (PART TWO)

Chris Heathcote

**Abstract:** Preservation work at the mine is drawing to its conclusion. Several further features have been discovered.

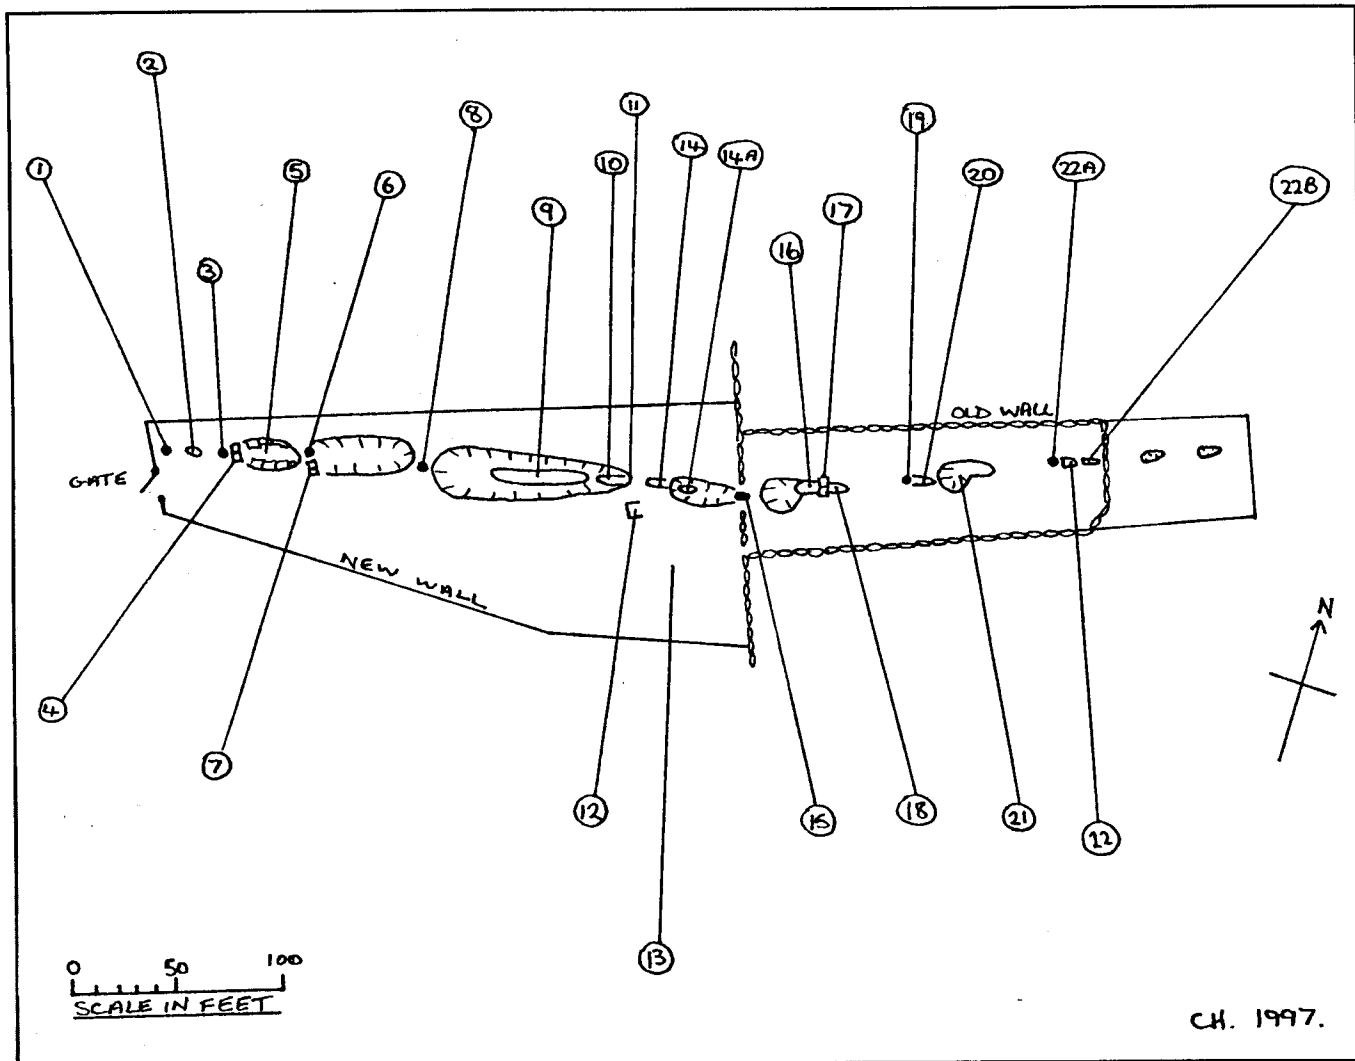
Fig. 1. Surface Plan of New Venture.

Throughout 1997 a small team of people have continued to preserve the surface remains at the mine, some of which were reported previously (Heathcote 1997). Fig. 1 shows the location of those reported in this article.

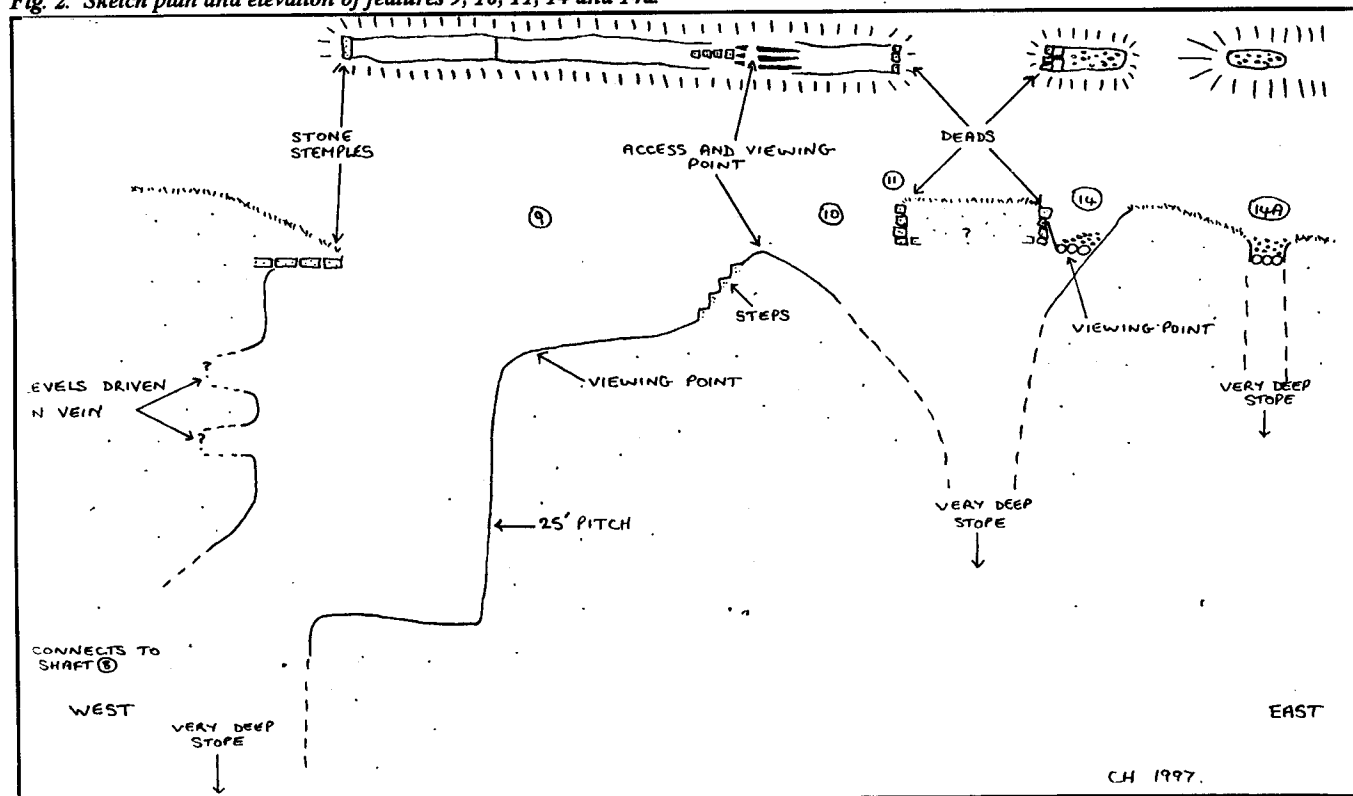
Fig. 2. Sketch plan and elevation of features 9, 10, 11, 14 and 14a.

9. This large collapse in the vein has been totally cleared of all the old coils of fencing, posts etc. This task was completed by using an ex-army hand winch supplied by a member of the group. This proved to be a very useful piece of equipment, saving a lot of time and effort. When all of the rubbish was cleared away it revealed a perfect example of a worked-out vein cavity. It is now possible to view this feature either from the surface or by entering the vein itself using the steps that have been built for easier access. These steps lead down onto a ledge of solid rock that has been left *in situ* by the miners. From this position it is possible to look down into the stope. This stope is very deep indeed, unplumbed but possibly a hundred feet or more. Also from this vantage point it is possible to see how the miners have covered parts of the vein cavity with waste material piled on to stone stemples, a typical feature of this site. The limestone 'cheeks' of the vein, above the ledge, are of very weathered rock, but lower down they appear to become more solid and stable. A fine example of a crinoid bed, can be seen in the northerly cheek of the vein, above the steps. (Preservation complete). (See Fig. 2).

- 10,11. This vein cavity was also filled with old coils of fencing etc. This was removed, again using the hand winch. This feature comprises a slope of debris leading down into another very deep stope working, above which can be seen a wall of deads of dubious stability. No work has been done to this wall because of its inaccessibility. It is hoped, however, that this feature will remain as it has done for many years. (Preservation complete). (See Fig. 2).

14. This is a vein cavity that was covered by a single sheet of corrugated iron. This was removed, at which time a large section of ground slipped into the cavity, blocking it six feet below the surface. This has enabled the group to partly fill the cavity with small plastic barrels covered with rocks and soil to make a small viewing platform that allows people to look down into the stope that connects with Feature 10 (preservation complete). (See Fig. 2).

- 14a. On Christmas Eve 1996, the author visited the site to carry out the old tradition of leaving a lighted candle in the vein, to bring good luck and fortune to the mine. On this occasion it was noticed that a collapse had occurred in the vein in the depression adjacent to Feature 14, the collapse was covered temporarily with a sheet of corrugated iron. It was not until the summer of 1997 that the collapse was filled in to the surface. This was once again done by using small plastic barrels wedged across the vein, these were then covered with rocks and soil. (Preservation complete). (See Fig. 2).

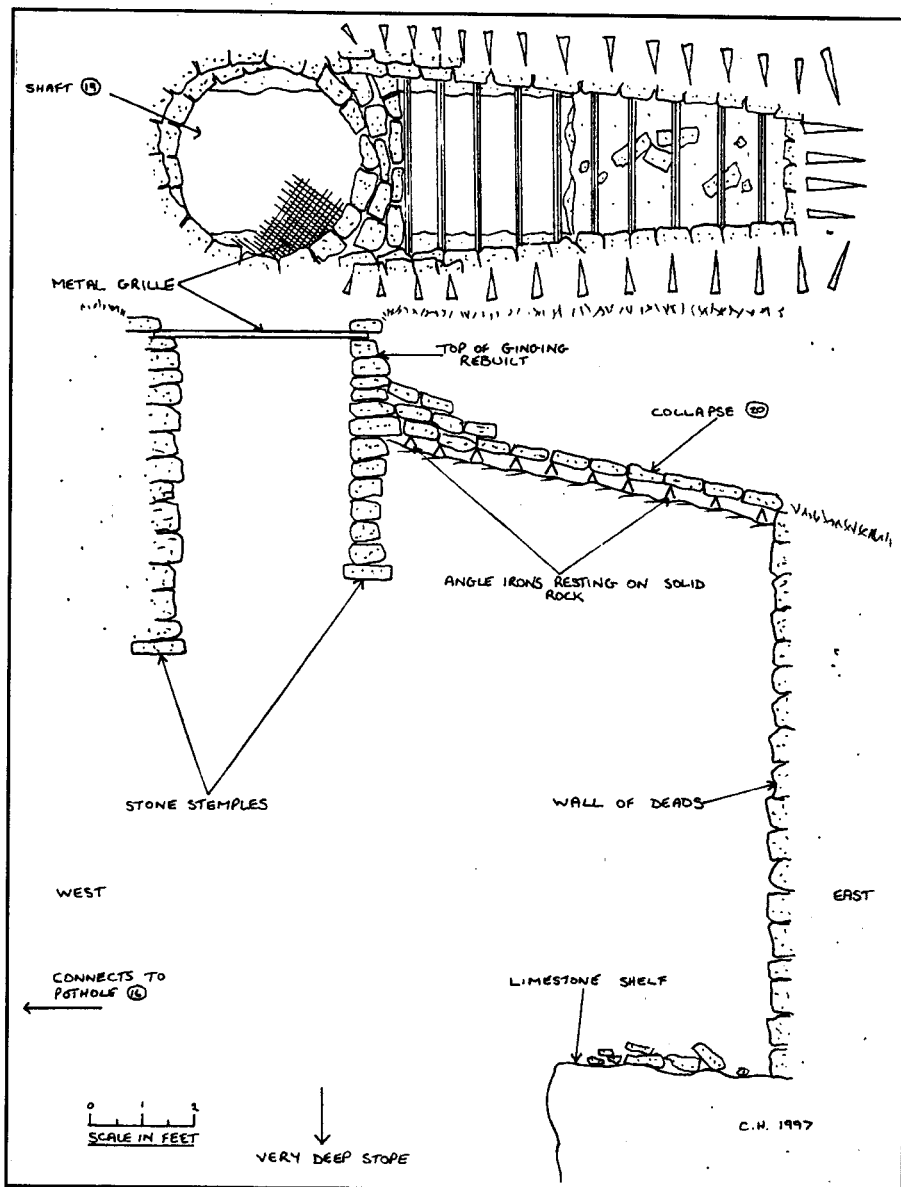
Fig. 3. Sketch plan and elevation of features 19 and 20.

19. The overhanging grass and moss that almost covered this shaft has been cut back revealing the shaft clearly. The shaft is similar in construction to the others on the site, having walls comprised of deads stacked on stone stemples across the vein. The ginging at the top of the shaft has been concreted to form a solid base for the grilles that have been placed across it. Part of the ginging was rebuilt to add strength to this feature. The shaft leads down into a stope of considerable depth, which connects with the natural pothole, Feature 16. (Preservation complete). (See Fig. 3).

20. The collapse adjacent to the shaft (19) was also almost covered by overhanging grass and moss. This was cut back to reveal the feature more clearly, at which time it was decided not to completely re-cover this excellent example of a worked-out lead vein. In the interests of safety it was decided to use short lengths of angle iron placed at intervals across the collapse, allowing people to look down into the stope with reasonable safety. These were concreted into place and a small wall has been built around the feature to add stability and also to hold back the very loose sides which comprise washed veinstuff. While this work was being done another wall of deads was discovered filling the eastern end of the vein. The wall is standing on top of a limestone ledge that leads into the stope noted in the previous feature. (Preservation complete). (See Fig. 3).

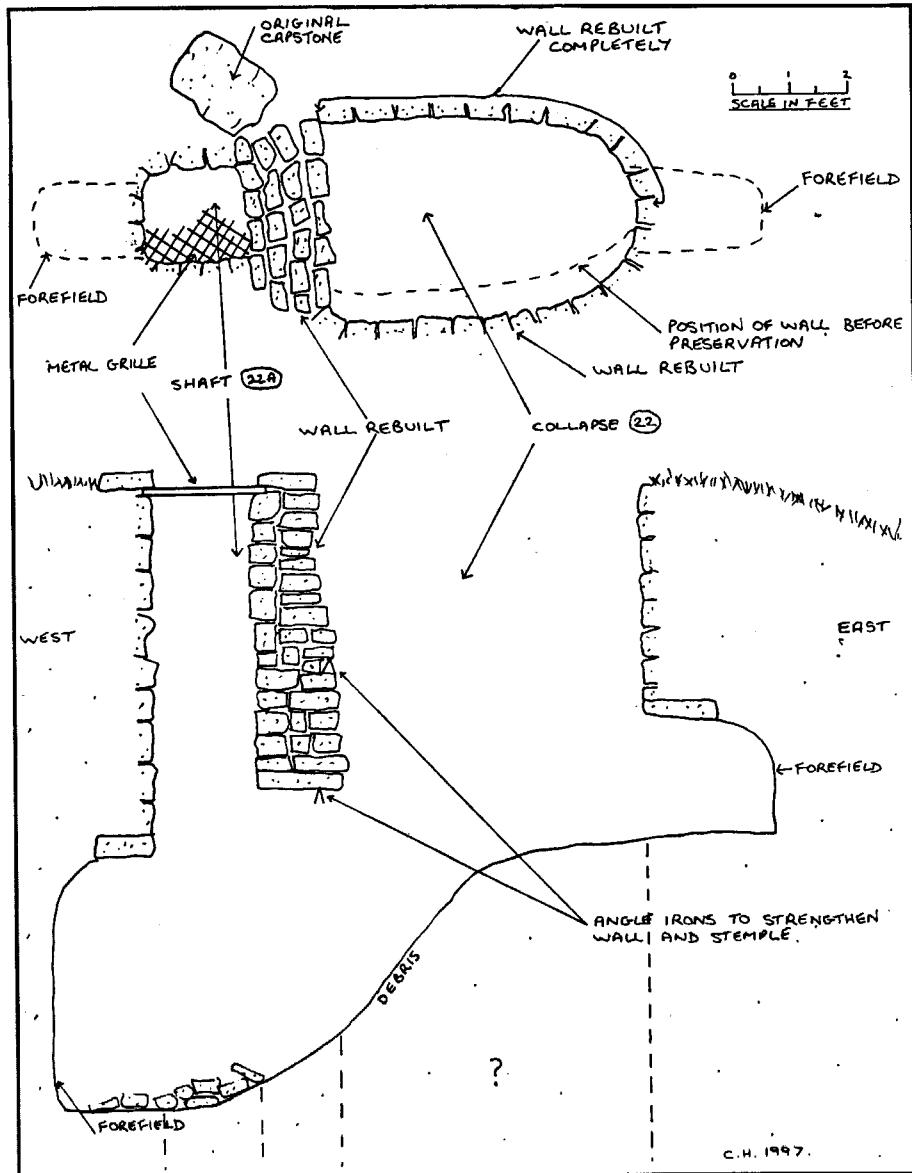
Fig. 4. Sketch plan and elevation showing features 22 and 22a.

22, 22a. The remains at this location were very overgrown. Vegetation has been cleared away revealing a partly walled exposure of the vein. It was found that this wall was in a very unstable condition and in danger of total collapse. It was necessary to dismantle the wall and rebuild it to its original position, using stone from other areas of the site. While this was being done it was discovered that a small shaft was located alongside this feature, separated from it by a single wall of deads stacked on a stone stemple. The stemple was too short to bridge the span of the vein, so the miners had wedged a small stone against the stemple to hold it in position, leaving this structure with very dubious strength. The shaft was capped over so it was necessary to dig down to locate the capstones. It was then discovered that the shaft was capped by two limestone slabs that were barely big enough to cover the shaft. Unfortunately one of

the slabs cracked while it was being removed and it fell to the bottom of the shaft, but the remaining one is now to be seen alongside the shaft. It was decided that the wall of deads needed to be strengthened to prevent the collapse of this feature. This was done by placing a piece of angle iron underneath the stemple to support it and another one was placed higher up the wall. The wall was then rebuilt and grouted with concrete to stabilize it. A grille has been placed over the shaft and concreted into position. Several discussions have taken place regarding the reasons why the miners have built such a structure for what appears to be very little reward: the forefields at this location seem to be short trial workings containing hardly any galena. It has been suggested that the feature could have been originally deeper than it is today, possibly a dual winding and climbing shaft. (Preservation complete). (See Fig. 4).
