DANE BOWER COLLIERY, WILDBOARCLOUGH

Dave Williams

Abstract: Whilst investigating the surface remains of the Buxton Coalfield the remains of Dane Bower Colliery were visited. An obvious collapsed adit which worked the Ringinglow Coal Seam, was opened and the mine explored as far as practical. The Abandonment Plans of 1922 show a considerable extent of workings beyond the limit of exploration.

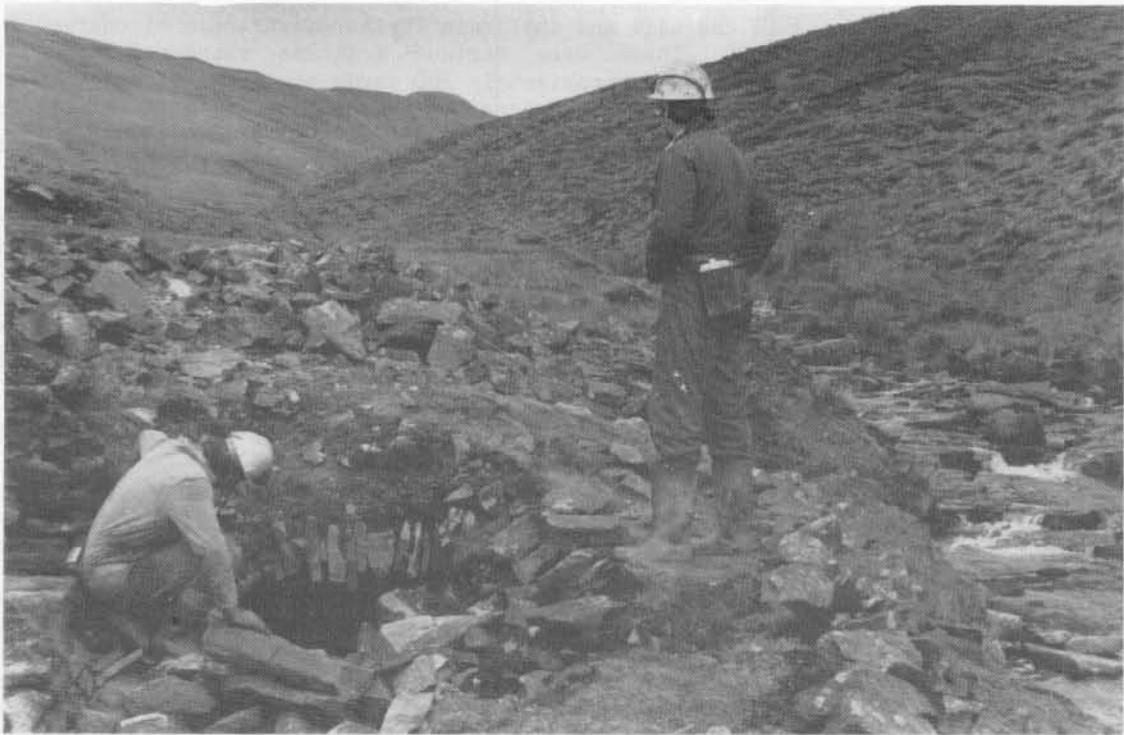
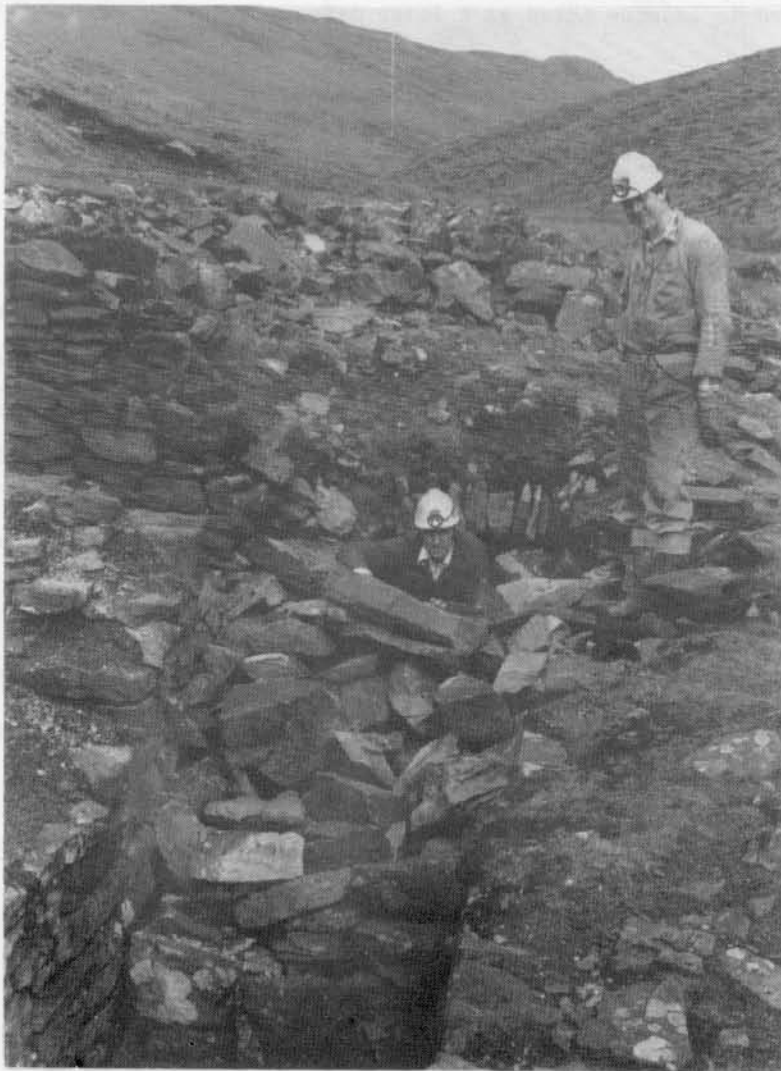
Danebower Colliery, Wildboardclough. photos by Harry Parker

There was a strong flow of water in the adit and the drain further downstream discharged sufficient ochre to turn the river bright orange. There were various articles abandoned along the adit including several pot land-drain pipes. Approximately 300 yards along the adit a shower of water rained down from a small hole in the roof. This appeared to coincide with the first junction in the level. Just beyond here the coal was seen for the first time dipping down at about 15° from the east.

Where the coal is seen there was the remains of a tub of fairly primitive nature. At this point another level crosses above the main adit and there may well have been an air-crossing here. To the right a low level with packs on either side leads back towards the day eye but is blocked by a fall. To the left the level is dry and passes a place where it seems that sampling of the coal took place probably during the last war. This level continues for some 300 or 400 feet before the air becomes too bad. Forwards at the crossing leads to a junction where the level gets wetter and the air becomes worse. At this point the exploration was terminated in the interests of safety. The excavation into the adit was backfilled and the colliery left in peace.
