# The Copper Slag Blocks of Hayle, Cornwall: Remains of a late 18th Century Industry

John Ferguson

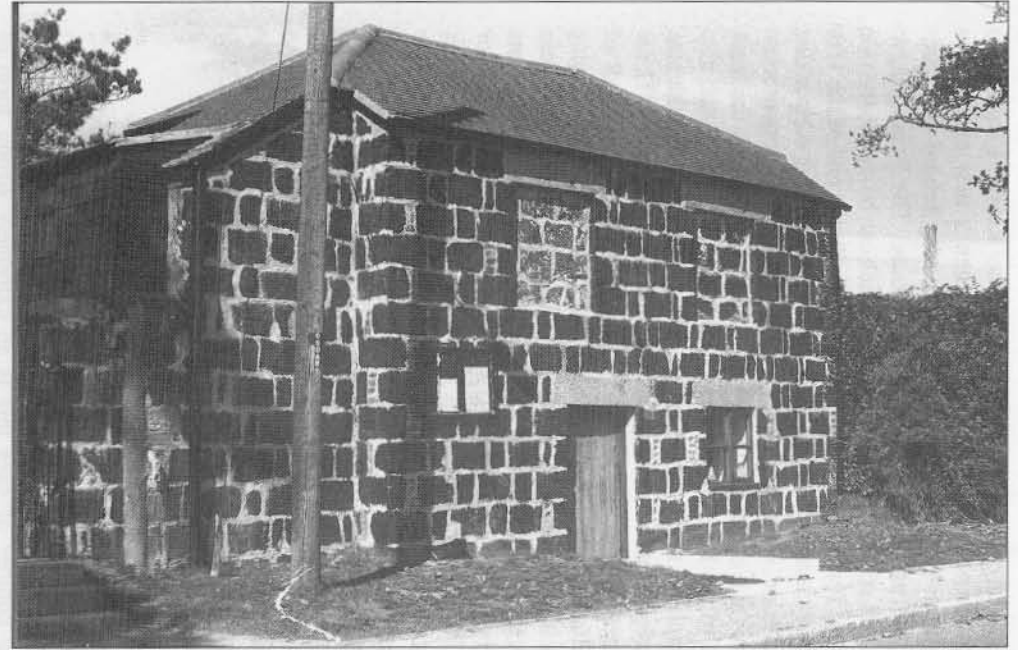
Plate 2. Phillack Church vestry (NGR SW 565384). Note bricks used as closers.

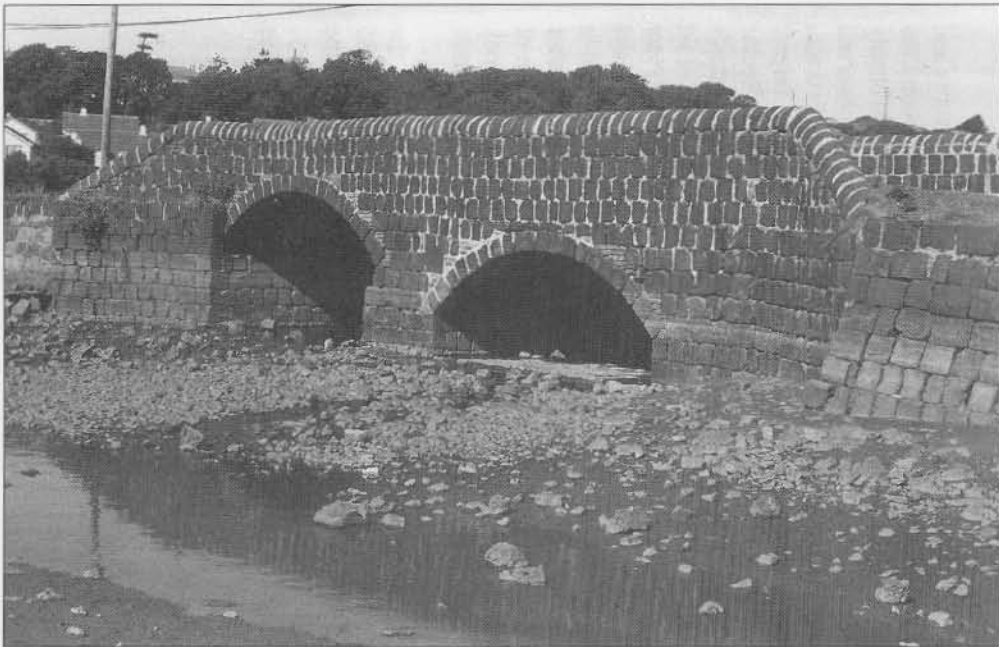
Plate 3. Bridge over Loggans Stream, between Copperhouse and Phillack. Note the height of the arches and batter on right hand revetment.

Revetments and quay linings are constructed in header bond, often with little overlap or offset. They are sloped back at 5°-10° to give a battered front face (Plate 3) and as can be observed at a number of sites this is an extremely strong form of construction and has proved ideal along the banks of the Copperhouse Canal. Phillack Vestry is constructed using Flemish Bond, that is alternate headers and stretchers. Because the blocks were difficult to cut, bricks are used as closers, as can be seen in Plate 2. Rectors Bridge is in the more common stretcher bond (Plate 3) and also uses bricks as closers. Note that 'ornamental' mitre shaped blocks are used as a coping on the side walls.

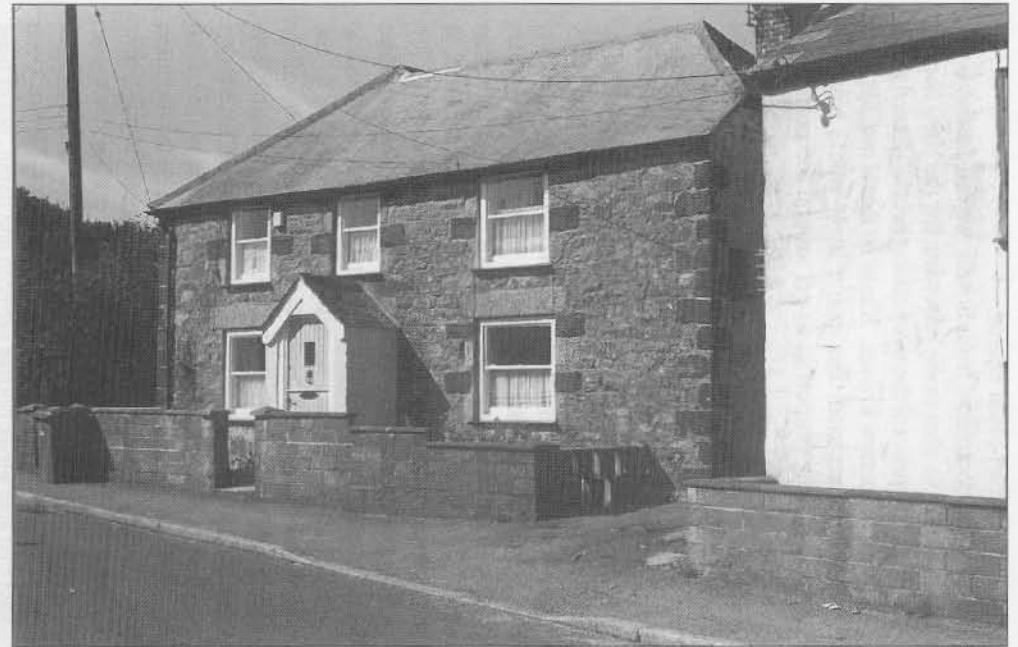
Plate 4. Cottage at Churchtown Rd, Phillack, illustrating the use of slag blocks in the quoins of a building.

One of the more commonly occurring use of the blocks is in the construction of quoins, either on the gable ends or lining doorways or windows, as illustrated in Plate 4. This particular use continued at least until the first decade of this century.
