THE MAURY AND BURFOOT MINES, TADDINGTON AND BRUSHFIELD, DERBYSHIRE

John Barnatt and Chris Heathcote

This note describes in outline what there is to see on surface at one of the best surviving but little known areas of lead mining in the Peak District. It is a sad fact that with the ongoing removal of surface hillocks for their gangue minerals and as part of agricultural improvement, there are only few places in the Peak District where you can stand and see lines of hillocks following vein after vein crossing the landscape and making a significant visual contribution to its character (Barnatt 2000; Barnatt and Penny 2004). A range of different types of features are present at the Maury and Burfoot Mines, described below, which mostly lie on the steep slopes to the south side of the River Wye at Millers Dale; difficulty of access has inhibited their removal.

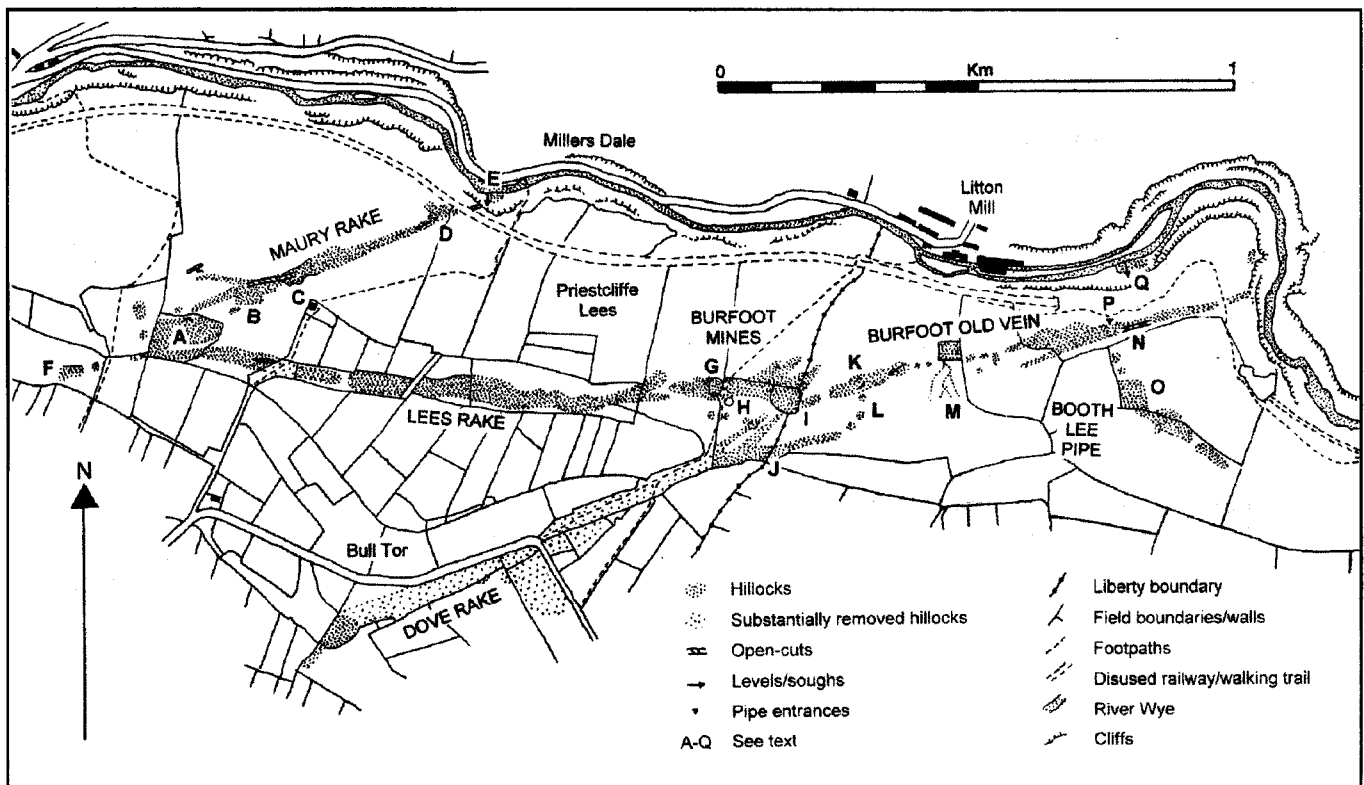
Fig. 1. Plan showing the location of veins at the Maury and Burfoot Mines.

The most obvious features at surface here are the hillocks that cross the steep slopes obliquely at a variety of angles, with Lees Rake/Burfoot Old Vein trending east/west and Maury Rake and Dove Rake north-east/south-west (Figure 1). All three rakes are depicted on 18th century mining maps (Roberts 1767; Cook n.d.) as comprising more than one line of mineralisation along parts of the veins, given various names in mining records, which are noted here, but for simplicities sake are each given a single or simplified name (as above). In the late 18th century, the eastern part of Lees Rake is shown on Cook's plan as running closely parallel to Burfoot Old Vein (alternatively named Swindales Vein). Further west Burfoot Old Vein is shown running diagonally up the hillside, diverging from Lees Rake and following a line of hillocks visible today, and then running closely parallel to Dove Rake. The south-western part of Dove Rake was sometimes known as *Bole Torr Rake*. An added complication occurs around the Booth Lee Pipe, where mining accounts indicate it intersected veins known variously as Lees Rake, Burfoot Old Vein and Torrtops Vein, the last either a further branch vein or an alternative name. Various parallel veins and also pipeworkings are also recorded at Maury Mine (see below).

There are also a series of specific features of interest. The most significant of these, following Figure 1, are:

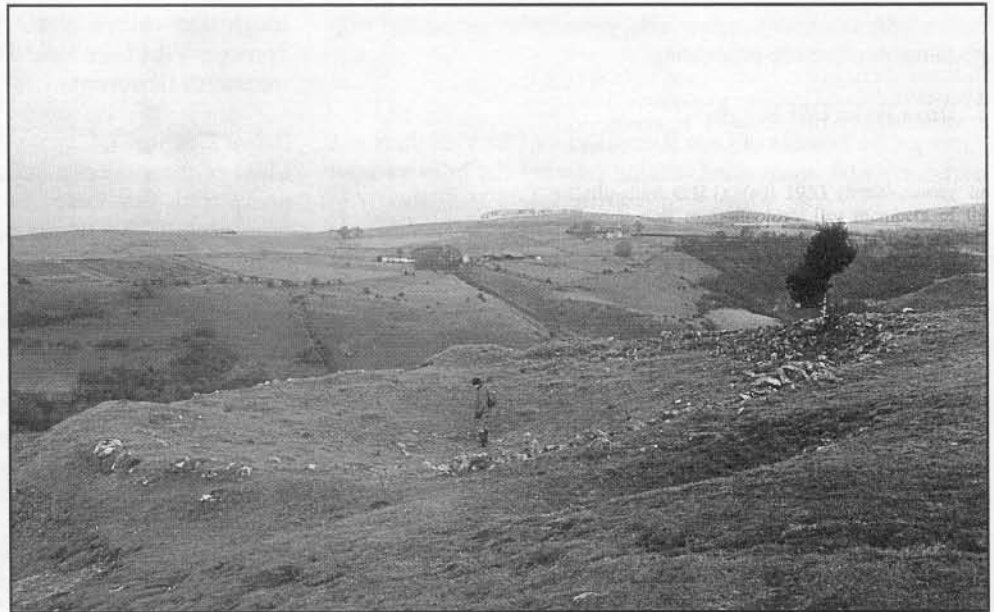
Fig. 1. The walled ore-washing pond adjacent to Lees Rake at the Burfoot Mines.

This walled pond adjacent to the public footpath has been terraced into the hillside with a high embankment and retaining wall on the downslope side (Plate 1). This is a fine example of

a dressing feature, with a deep central circular pond, now dry, surrounded by more gentle sloping sides to the enclosing wall. It has clearly been used for washing and possibly buddling ore, as the gently sloping sides surrounding the pond hollow comprise clay and other fine material dumped as a result of these processes; the floor surrounding the pond was presumably originally flat. The pond appears to be shown on a late 18th century mine map (Cook n.d.) and is depicted on the tithe map of 1848 (Gratton 1848). To the west, on the other side of the field wall there is a short sinuous stretch of a possible leat leading towards the pond.
